Home Inspection Report

1234 Winward Way, Hartland, WI 53029

Inspection Date:

Wednesday May 20, 2015

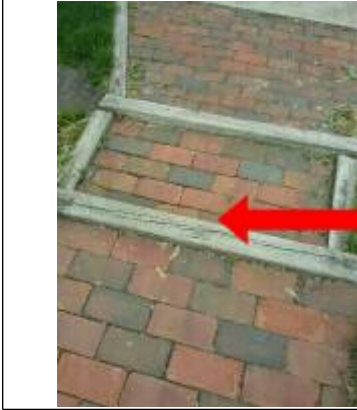
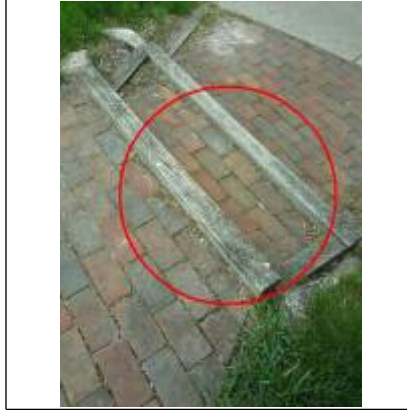
Comments Uneven slabs in walks, could be a tripping hazard, recommend repair and/or replace .
 Wood frame around front and back steps represent a tripping hazard recommend repairing.

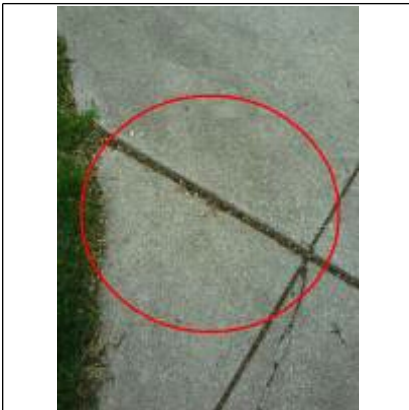
Comments Driveway had some settlement, but usable, recommend repair .
 Trip hazard in driveway, recommend repair and/or replacement .

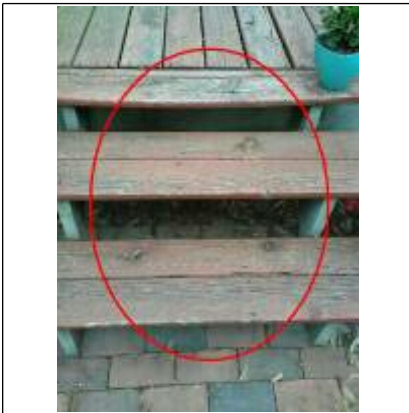
Comments Step risers are uneven, may present a trip hazard. Recommend repair and/or replacement .
 Recommend adding a middle stringer on stairs for additional support.

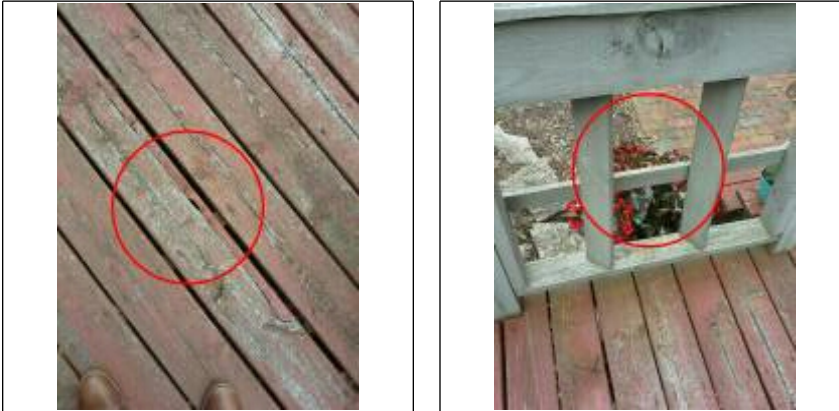
Comments Recommend painting or treating wood.
 Damaged wood on deck recommend repair and/or replacement.
 For added safety recommend balusters be spaced a maximum of 4" apart - safety concern for small children.
 Railings recommended for deck.
 Bolts in underside of deck rusted replace as needed.
 Recommend additional support under deck, some areas were deflecting.

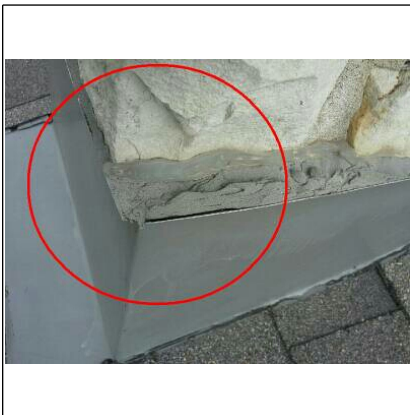
Comments Pulled away from chimney - recommend sealing (marginal)
Roof flashings appeared to be satisfactory, recommend sealing chimney flashings though.
